## STEP 1: DETERMINATION OF SIGNIFICANCE STAFF REPORT

**Site:** 64 Medford Street

Case: HPC.DMO 2021.11

$\textbf{Proposal:}\ Demolish\ principal$

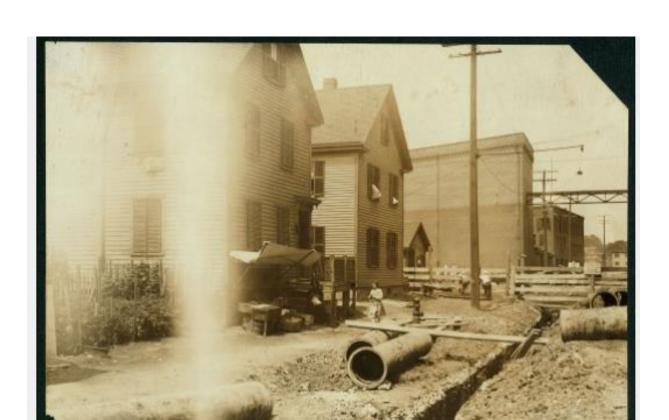
Lastly, the following photo from c.1912 by Lewis Hines was found in the National Child Labor Committee Collection of the Library of Congress showing a child in front of 64 Medford Street in Somerville.
